**DEPARTMENT OF TRANSPORTATION****DIVISION OF ENGINEERING SERVICES**

Quality Assurance and Source Inspection

Contract #: 04-0120F4Cty: SF/ALA Rte: 80 PM: 13.2/13.9File #: 69.28**WELDING INSPECTION REPORT****Resident Engineer:**Siegenthaler, Peter**Address:** 333 Burma Road**City:** Oakland, CA 94607**Report No:** WIR-018383**Date Inspected:** 28-Nov-2010**Project Name:** SAS Superstructure**OSM Arrival Time:** 700**Prime Contractor:** American Bridge/Fluor Enterprises, a JV**OSM Departure Time:** 1900**Contractor:** Zhenhua Port Machinery Company, Ltd (ZPMC), Changxing Island **Location:** Shanghai, China**CWI Name:** Mr.Xu Le Fung.**CWI Present:** Yes No**Inspected CWI report:** Yes No N/A**Rod Oven in Use:** Yes No N/A**Electrode to specification:** Yes No N/A**Weld Procedures Followed:** Yes No N/A**Qualified Welders:** Yes No N/A**Verified Joint Fit-up:** Yes No N/A**Approved Drawings:** Yes No N/A**Approved WPS:** Yes No N/A**Delayed / Cancelled:** Yes No N/A**Bridge No:** 34-0006**Component:** Tower and Orthotropic Box Girder (OBG)**Summary of Items Observed:**

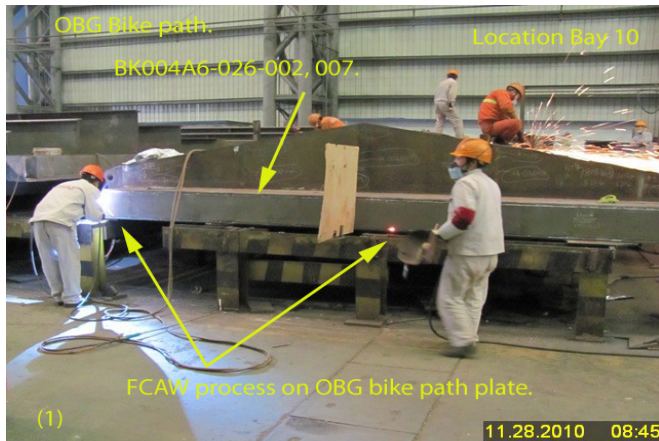
This QA Inspector observed ZPMC qualified welding personnel identified as 052075, 040533 Perform Flux Core Arc Welding (FCAW) on OBG Bike path plate. Joint identified as BK004A6-026-002, 007. ZPMC QC Identified as Yu Zhi Lai. The welding parameters as measured using QC's calibrated instrument appeared to be in general compliance with WPS-B-T-2332-Tc-P4-F. For more information see below attached picture number 1.

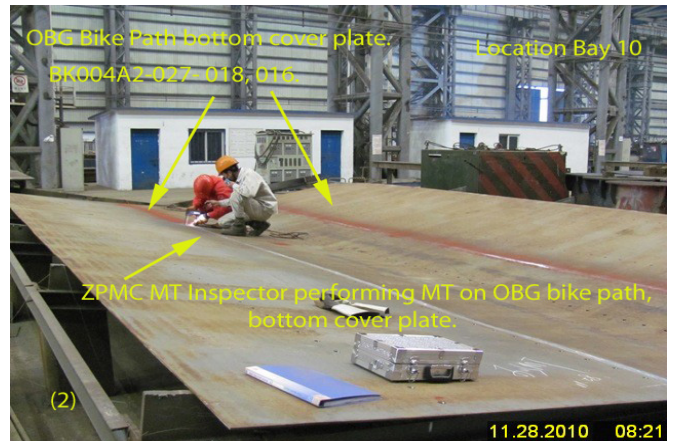
This QA Inspector observed ZPMC Magnetic Particle Testing Inspector, performed MT on OBG Bike path Bottom cover plate weld. Joint identified as BK004A2-027-018, 016. For more information see below attached picture number 2.
